**I metodi della ingegneria antincendio a supporto
della ingegneria forense e della analisi degli incidenti occorsi:
un ulteriore strumento di indagine**

Relatori: L. Fiorentini (TECSA S.r.l.)*, B. Chiaia, L. Marmo (Politecnico di Torino), V. Puccia (Vigili del Fuoco)

The Thyssen Krupp fire

- **Location:**
Thyssen Krupp plant, Turin, 12/06/2007
- **Plant Involved:**
Pickling and Annealing line N° 5, inlet (unrolling) section.
- **Main features:**
Small oil and paper fire which suddenly evolved into a jet fire
- **Personnel directly involved:**
8
- **Fatalities:**
7

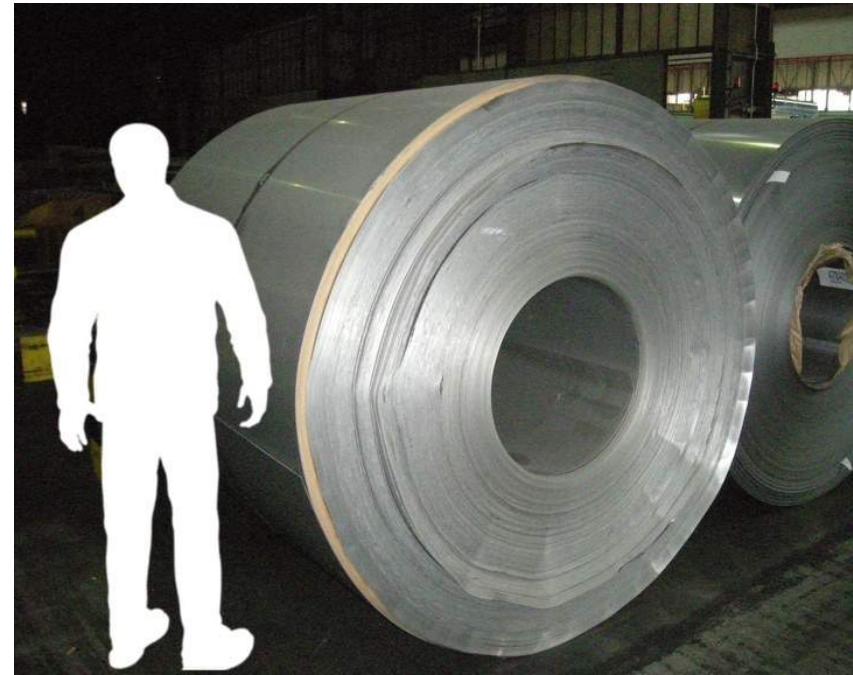
The plant and the process

Pickling and annealing of stainless steel coils

Light green: discontinuous

Orange: continuous

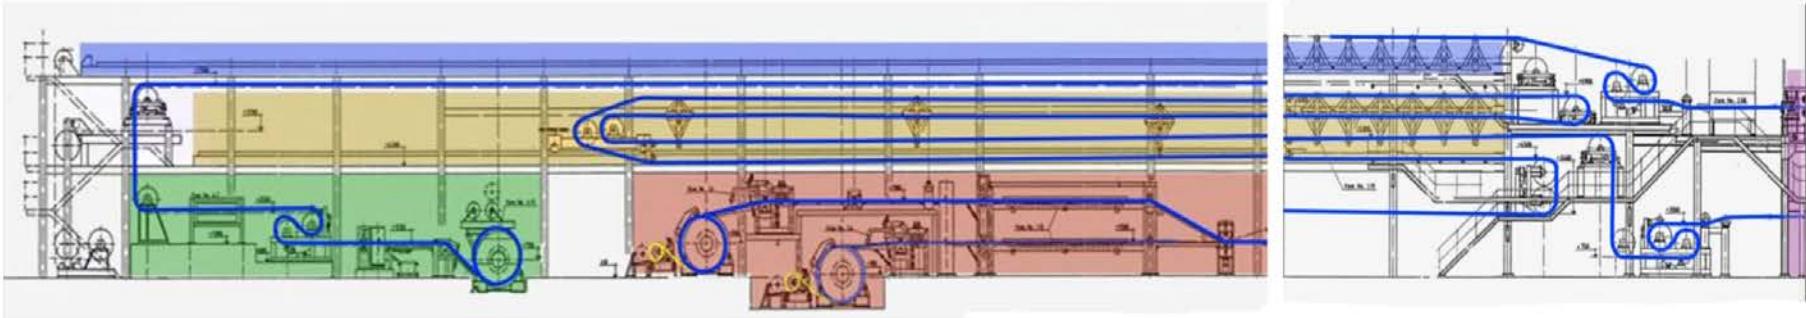
The plant and the process

- Process and field variables.

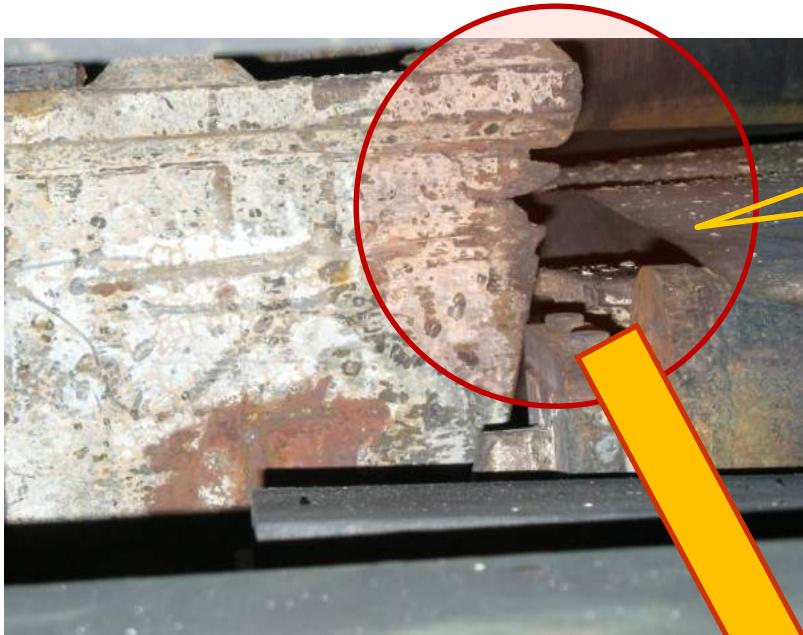
Heat and flame damages

Coil

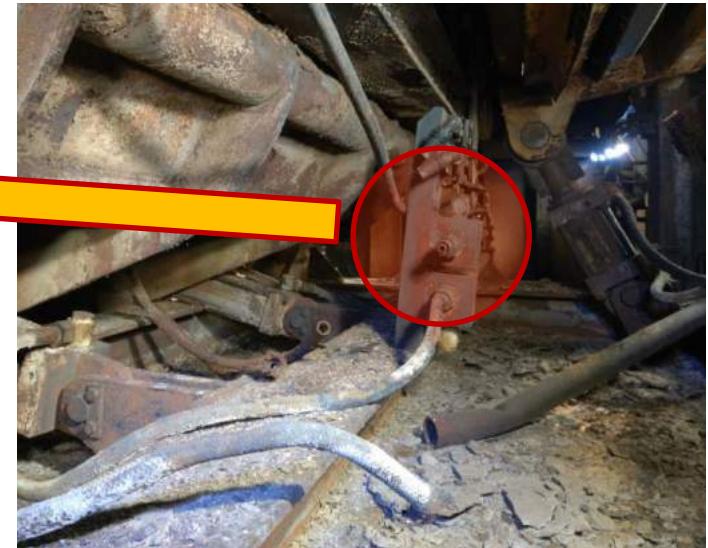
Jet fire causes

Sudden collapse of an hydraulic pipe which was fed by pump station (140 bar).

Ignition by the local fire

Hydraulic oil: Agip LH 46 (FP 220 °C), Fuchs Renolin HTF 46 (FP 202 °C)
